Tata Steel UK Limited

Electric Air Furnace (EAF)

Stage 1 and 2 Arboricultural Impact

Assessment Report

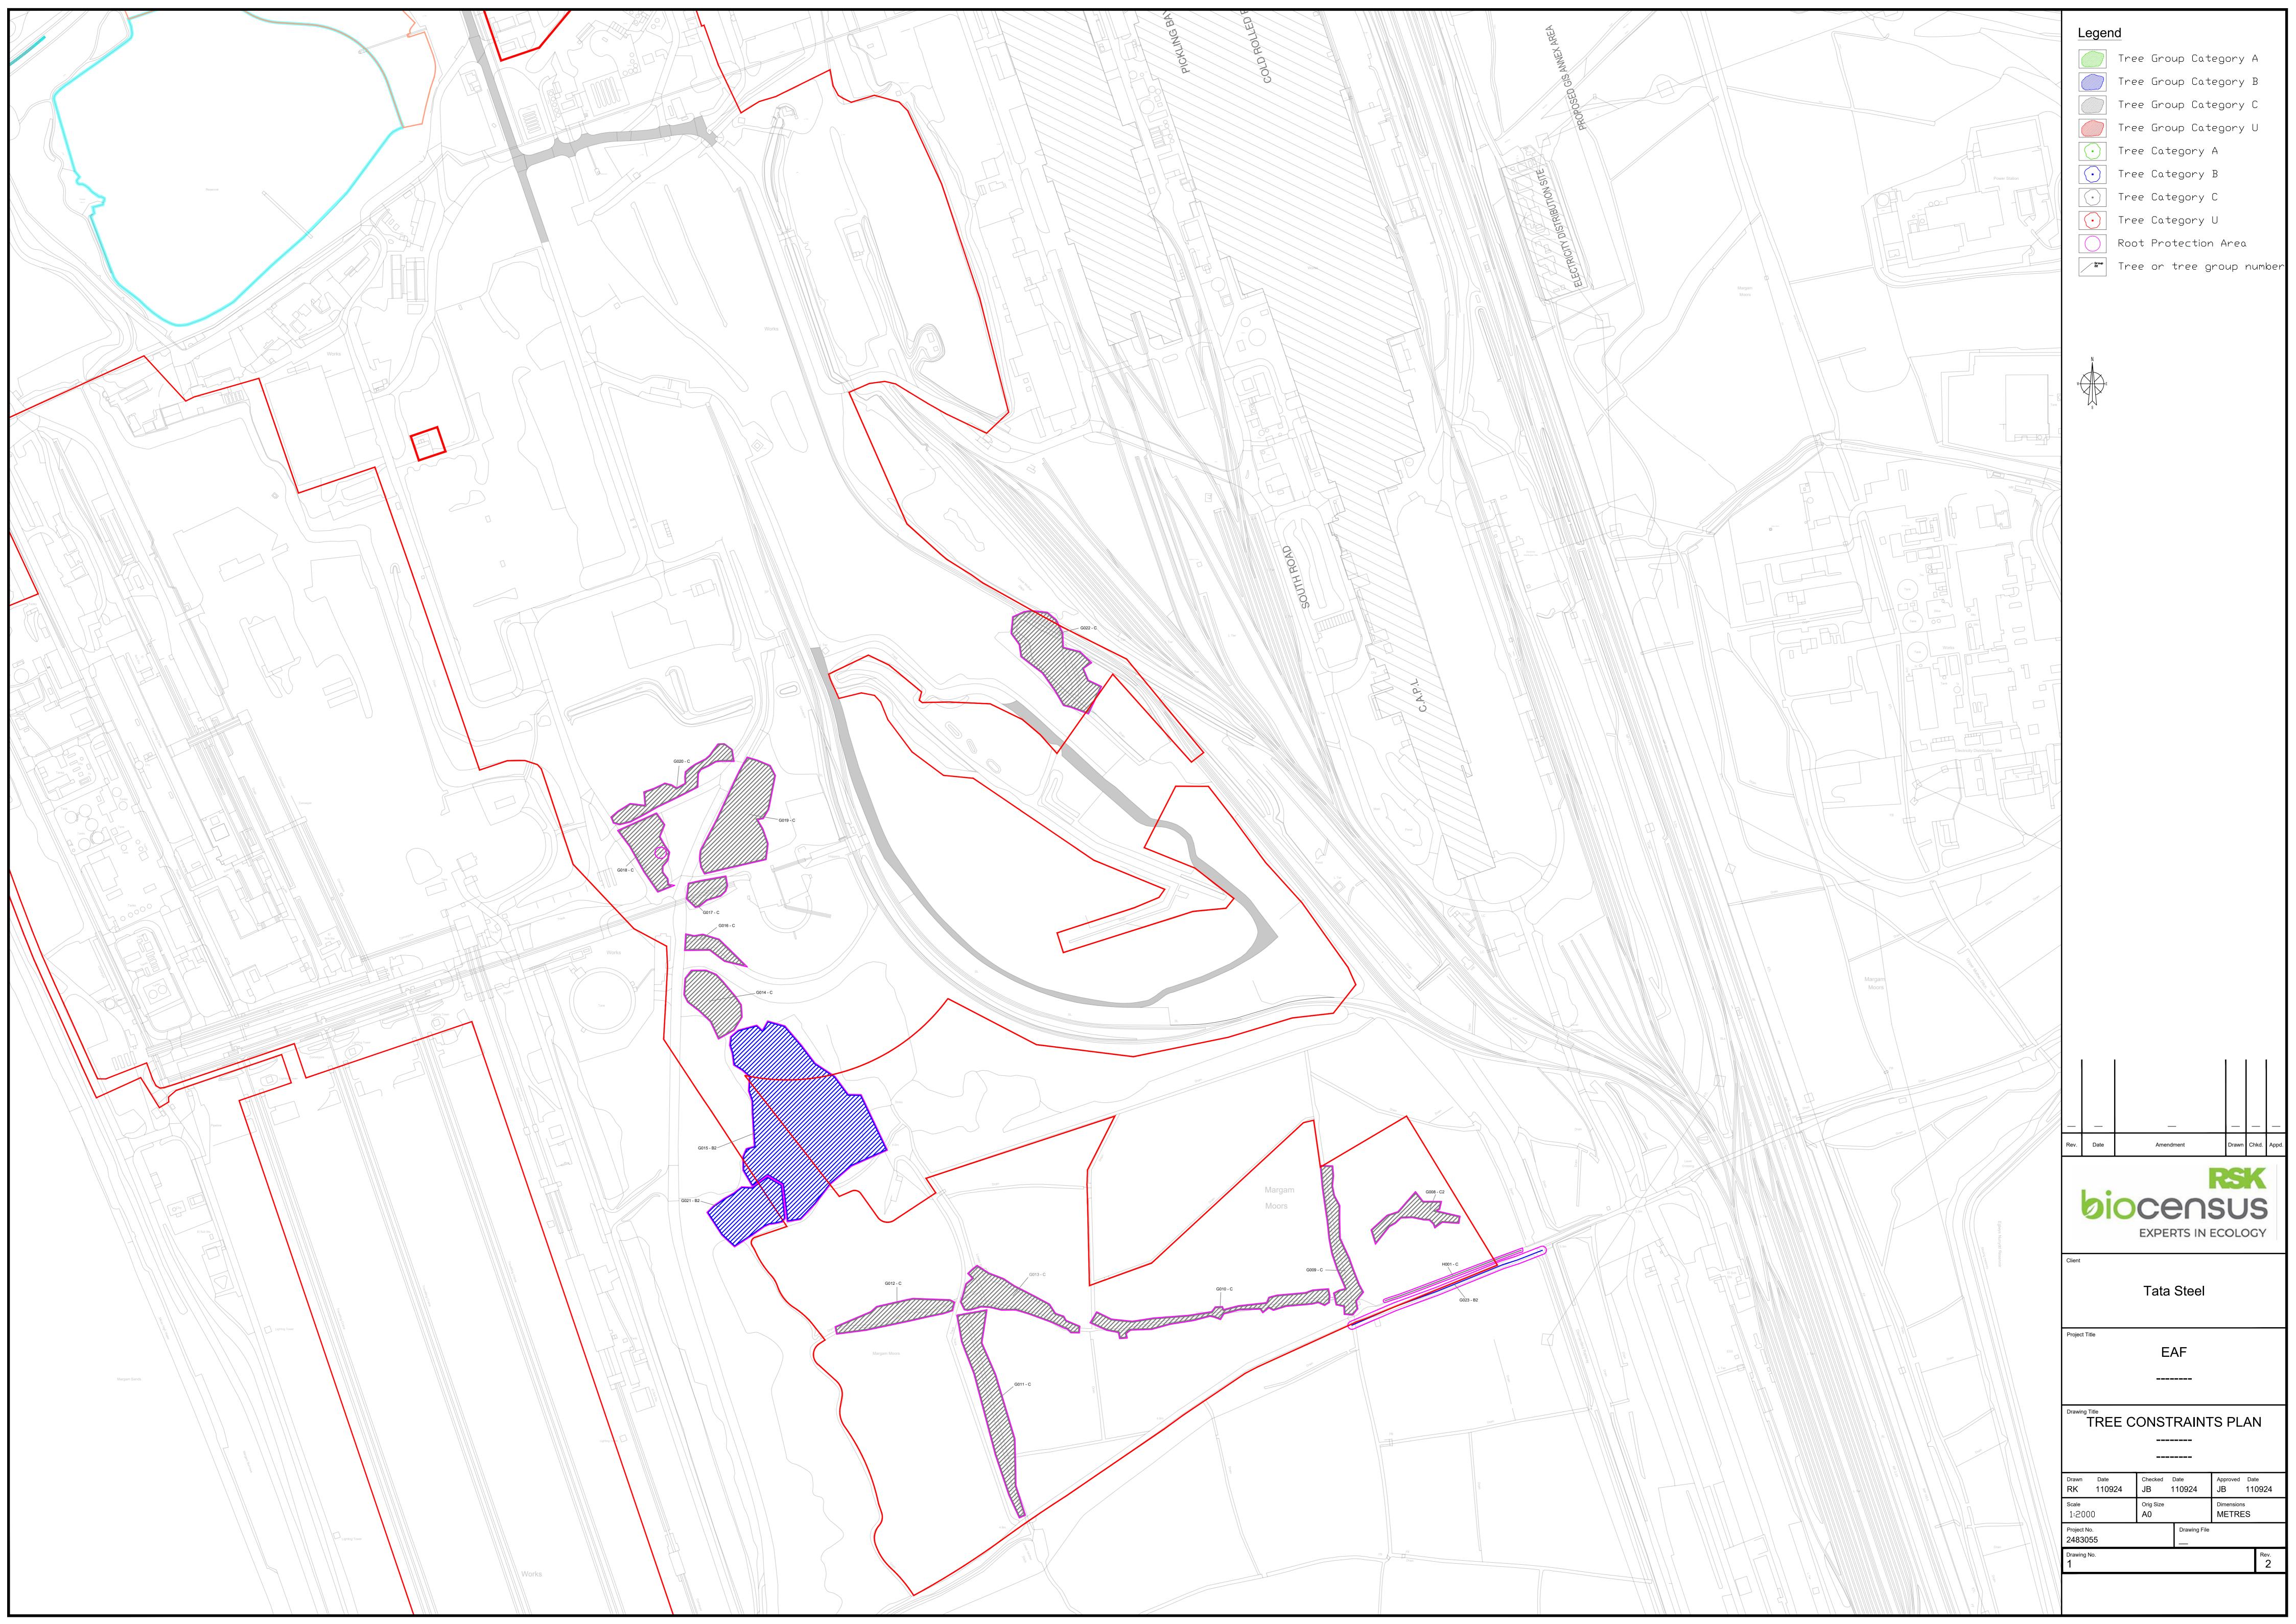
APPENDIX 2: TREE CONSTRAINTS PLAN

A total of 16 groups of trees and 1 hedgerow were recorded. The most prominent feature is G015 towards the centre and west of the site.

Of the 16 features recorded: 3 were Category B (moderate value) and 13 were Category C (low value) (hedgerows do not qualify for a category).

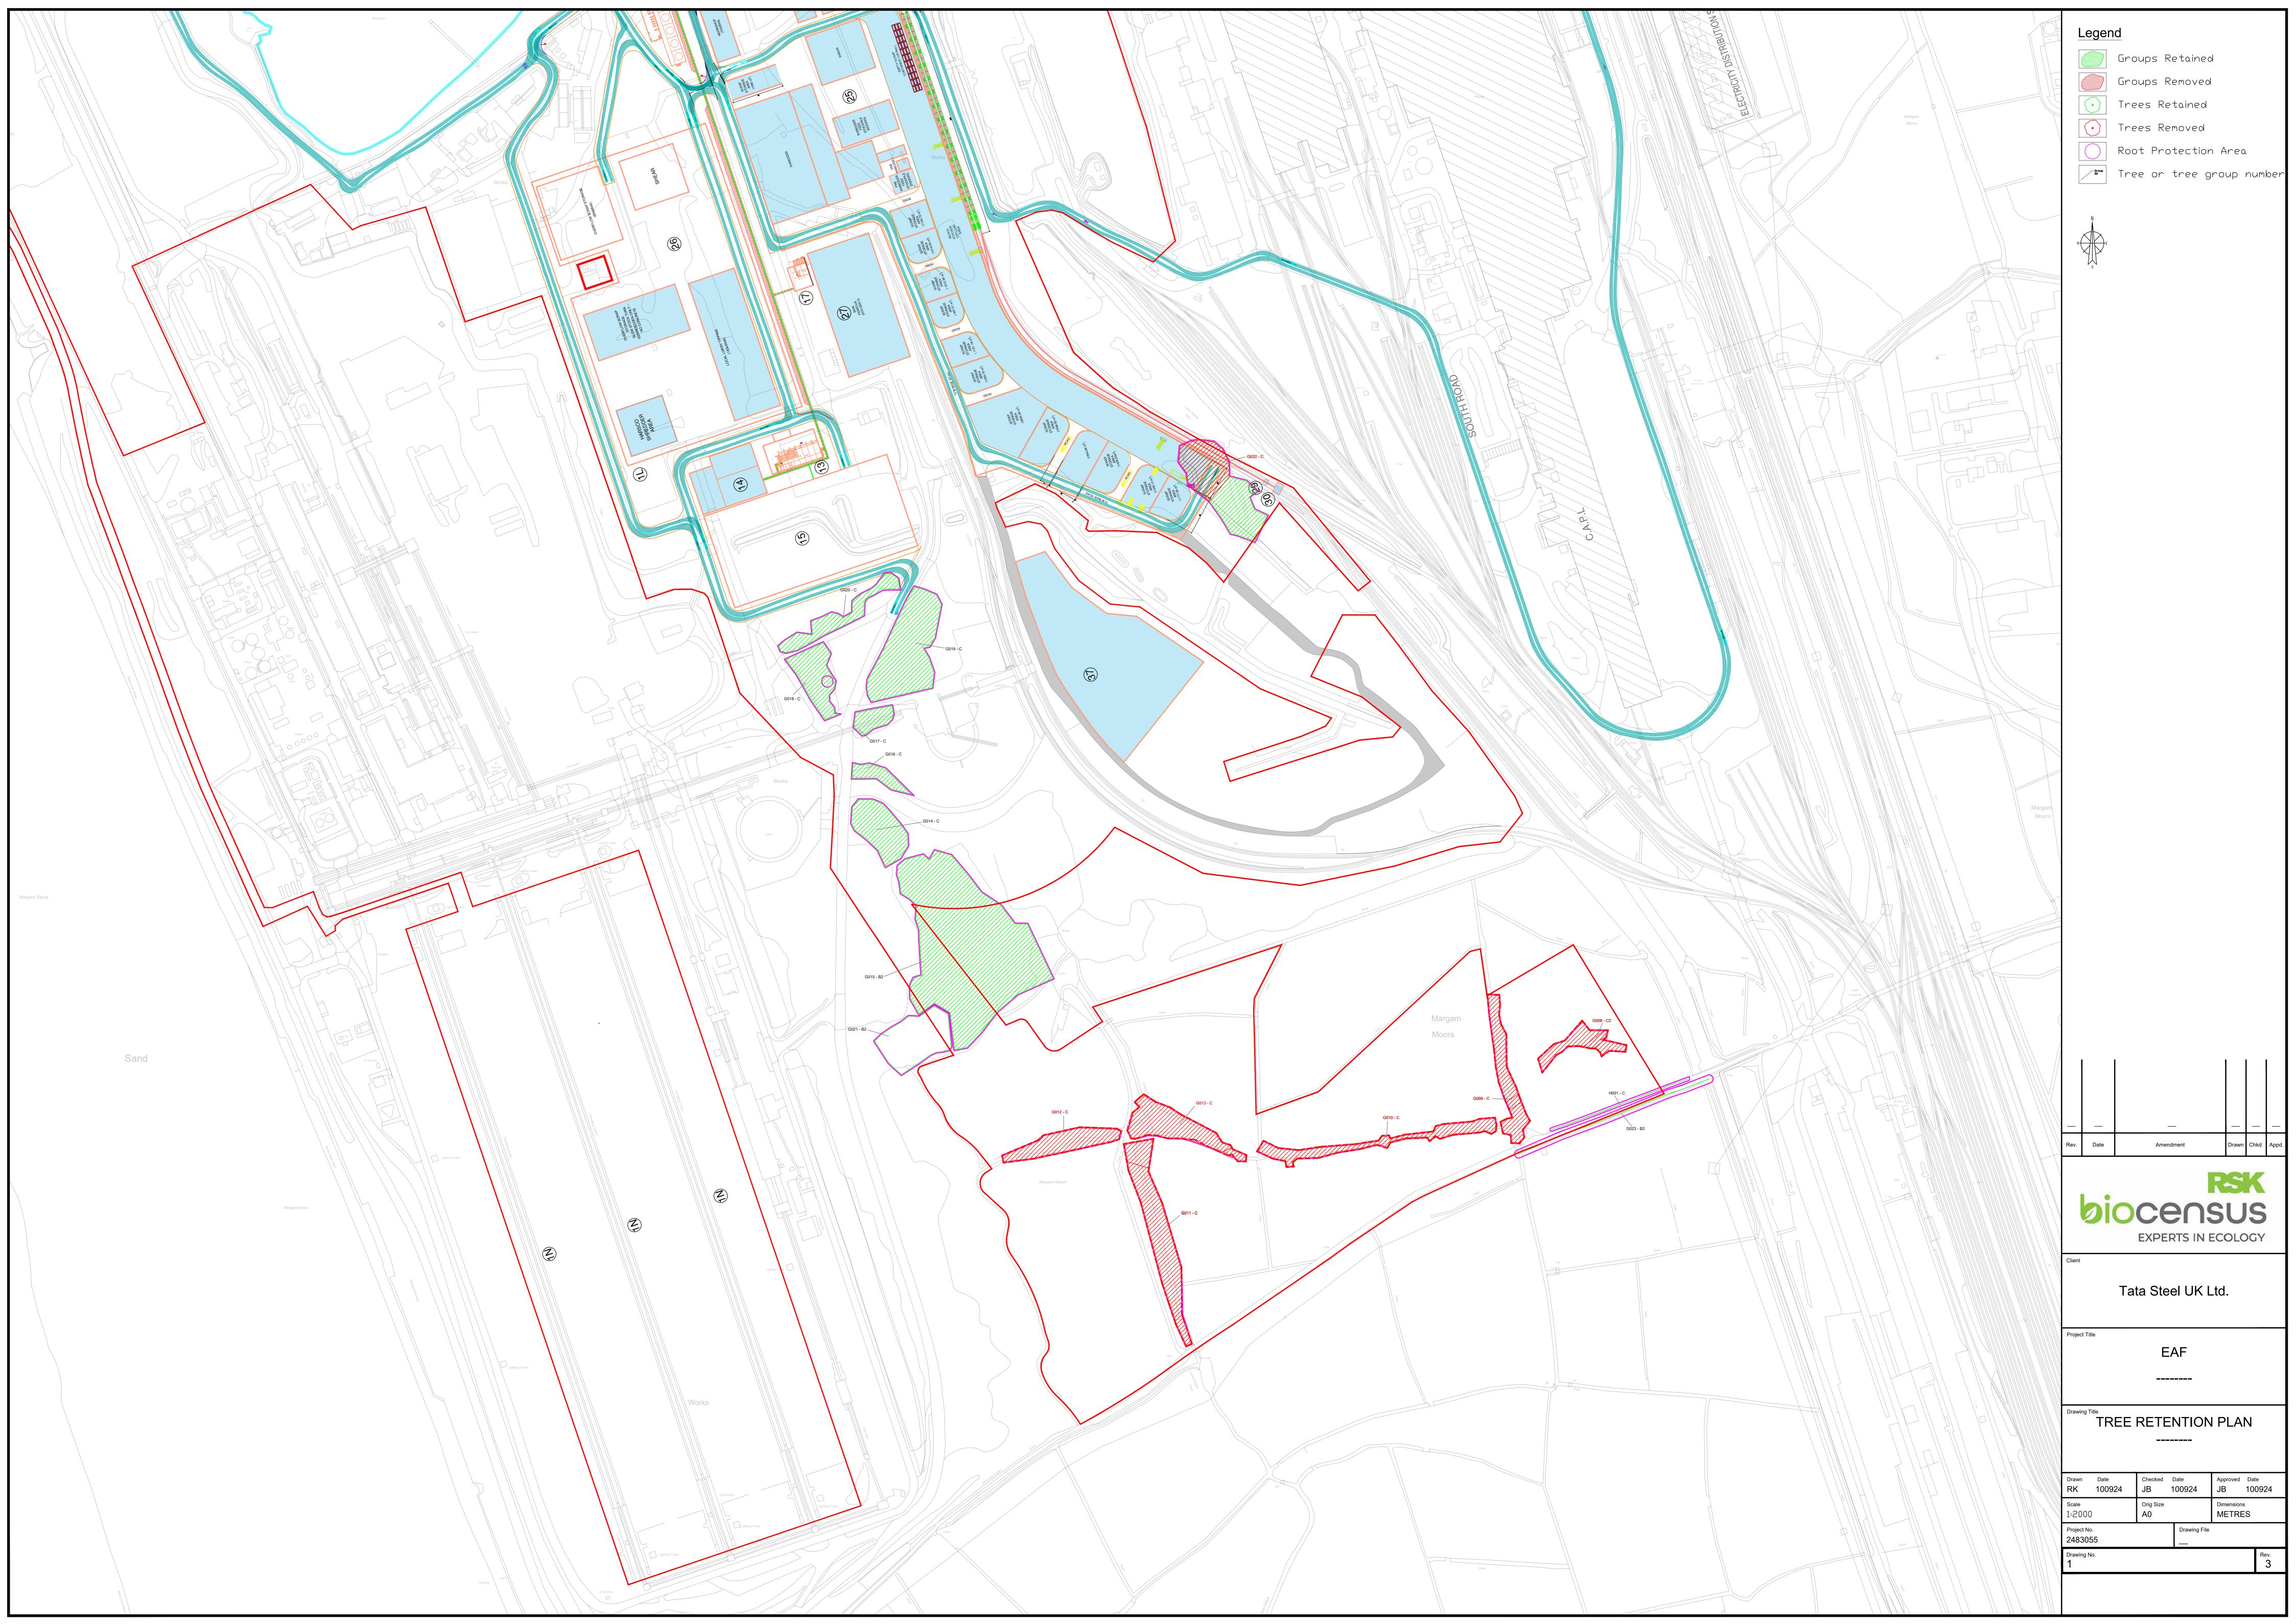
APPENDIX 3: TREE IMPACT AND RETENTION PLAN

Under the current proposed layout, 7 features are likely to be required to be removed. These are all category C features.

All but one of the losses are relating to the ditch side groups in the southern fields which comprise predominantly Willow and Hawthorn groups of low value from an arboricultural perspective, many with sections of low level shrubs and reeds with no trees. One group (G022) may require partial removal to facilitate the proposed scrap storage area and access track.

Protective fencing will be required around the retained trees, and this should be to a sufficiently robust specification to ensure protection of its surrounding ground conditions.
