Electric Arc Furnace

Water Vole and Otter Survey Report

2487033 P&C EAF (Rev00)

MAY 2024

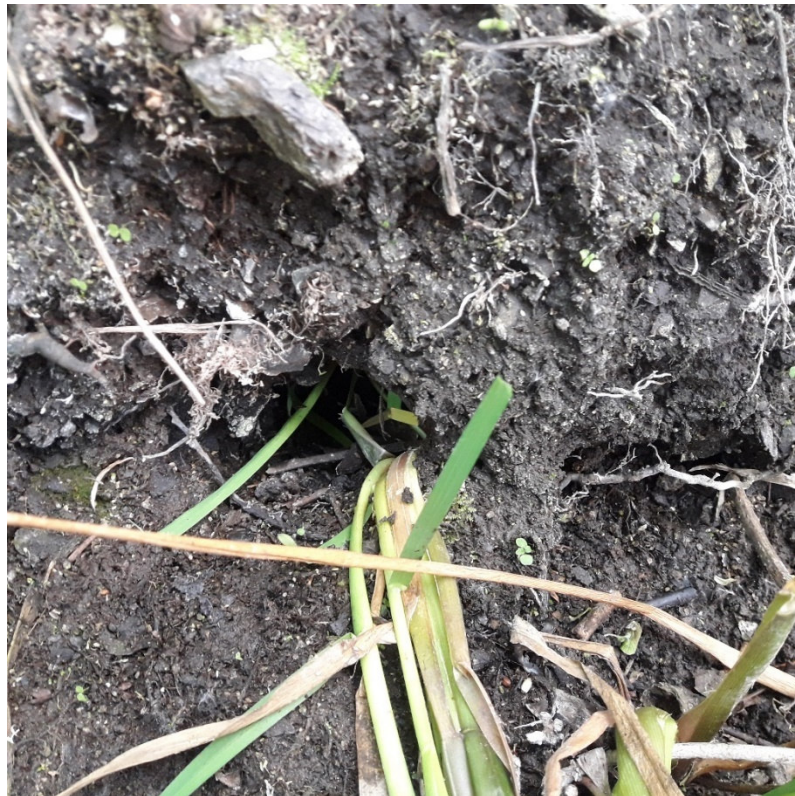
- 3.2.2 No definitive evidence of water vole e.g. latrines/ droppings were observed during the surveys on either Lower Mother Ditch (North) or the Lagoon. Small mammal evidence was however recorded on Lower Mother Ditch (north) in the form of a single burrow, 4-8 cm in width and oval in shape (Plate 1) and a chewed reed stem. This is considered evidence of the presence or bank or field vole and no evidence to suggest the presence of water vole.

Plate 1: Possible water vole burrow Lower Mother Drain (North)

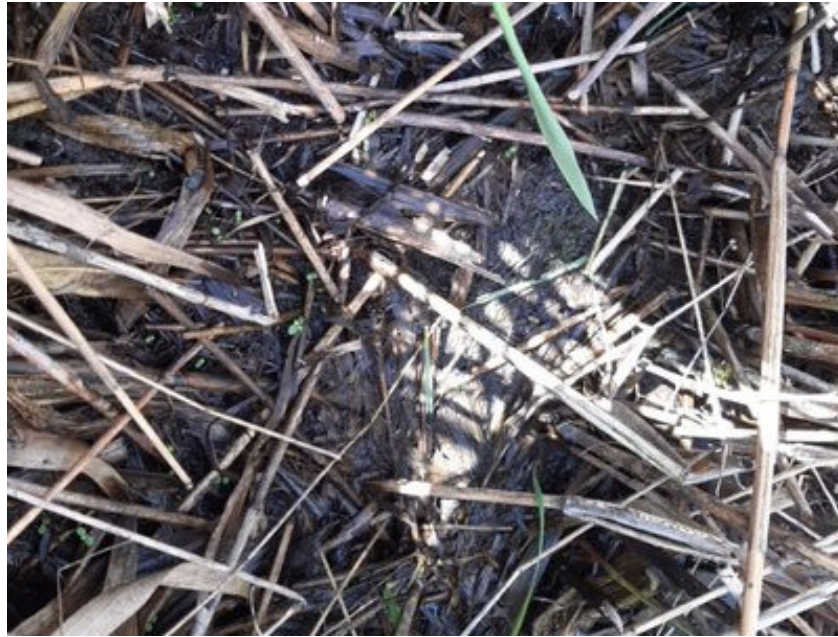
Plate 6: Small mammal feeding evidence.

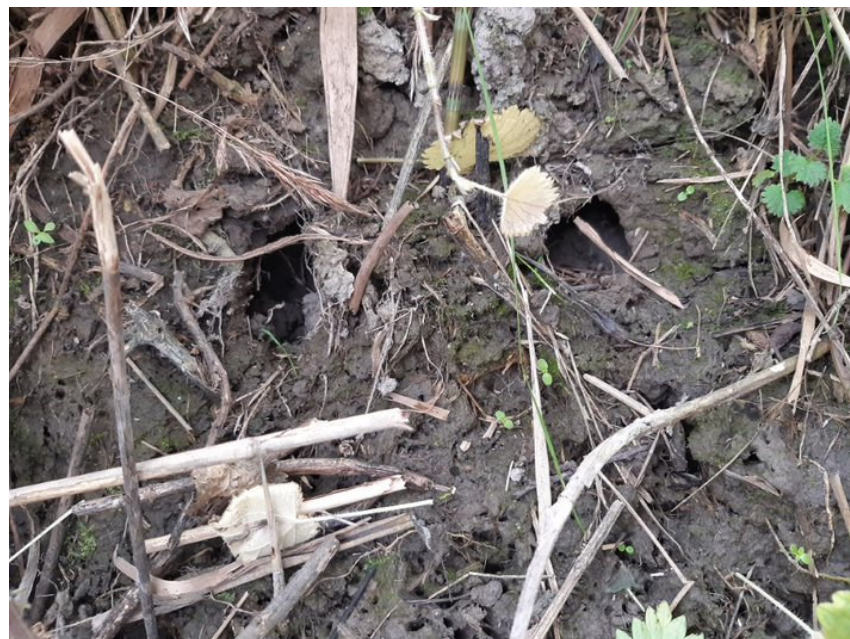
- 3.2.3 Numerous burrows were recorded several of which were the right size for water vole (4-8 cm diameter and oval in shape) (Plate 7), however given the lack of droppings and other evidence these burrows are considered to be either rat burrows or burrows of a now extinct water vole population.

Plate 7: Possible water vole burrows.

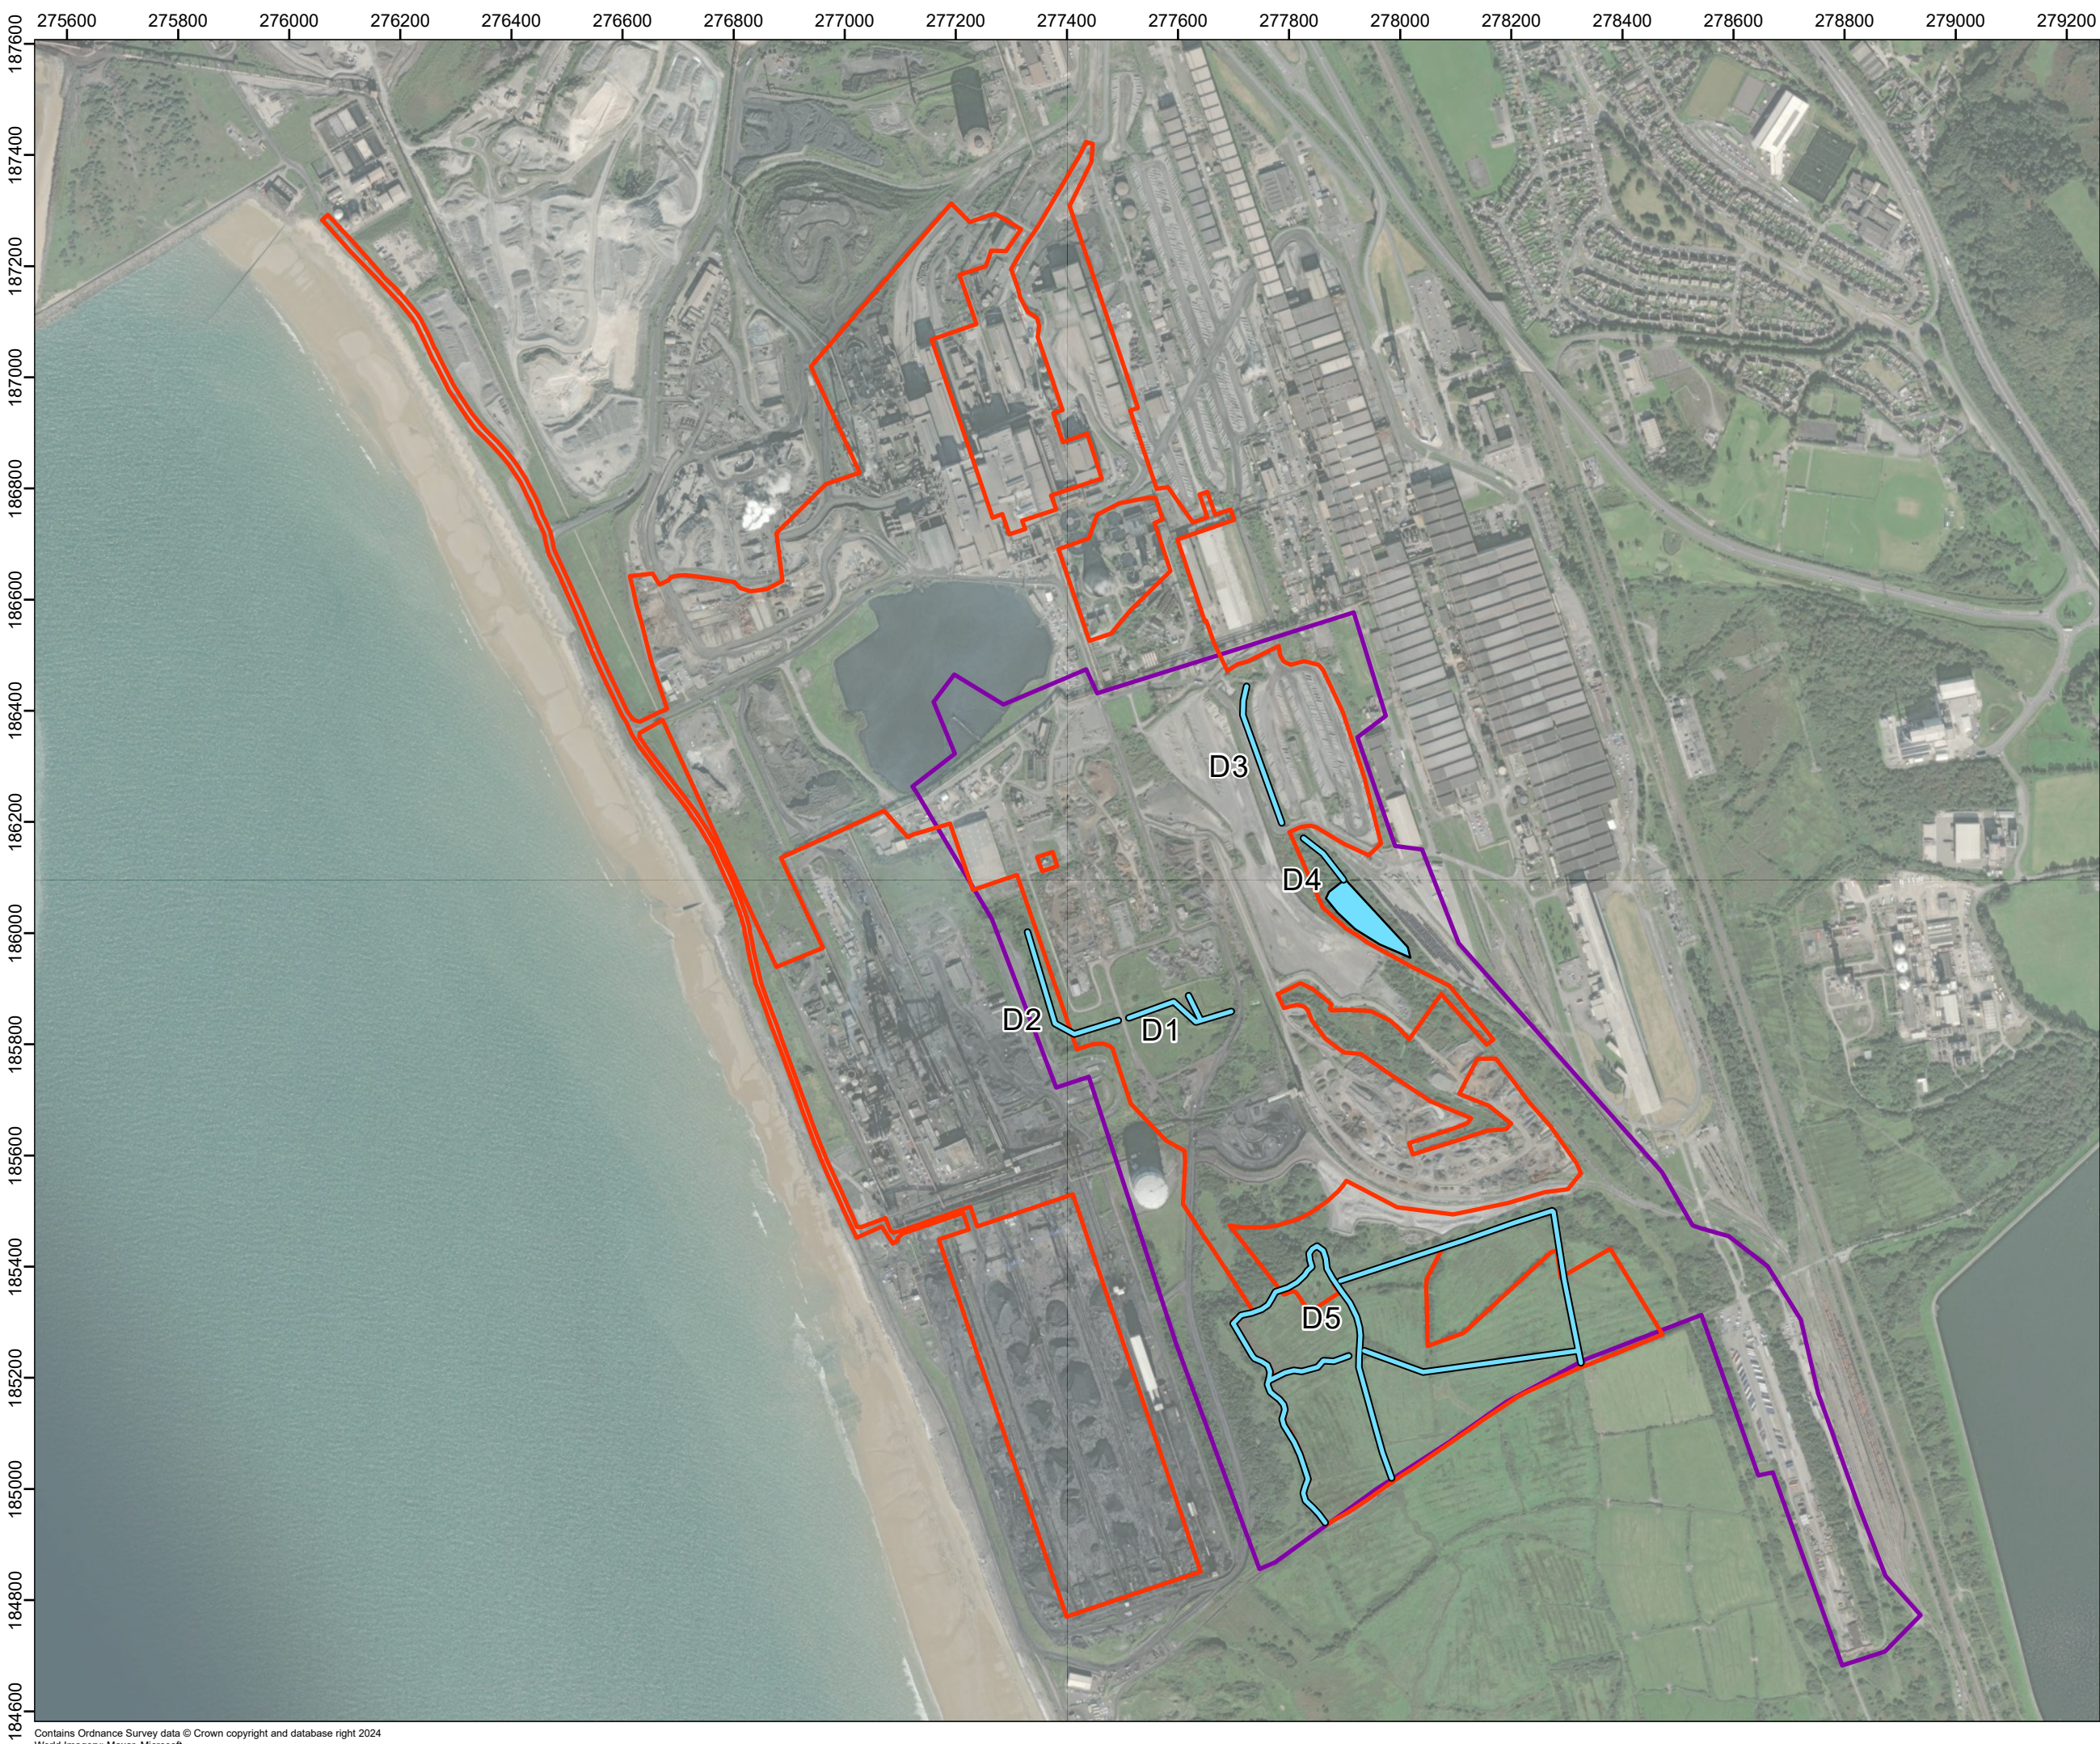
Figure 1 – Ditch Locations

- 2.1.1 The ditches were surveyed between 1 and 8 October 2021 by Jan Skuriat and 25th and 26th April by Ben Faulkner and Kate Gwynn. The water vole rafts were checked monthly during dormouse/ reptile surveys. All surveyors have experience in identifying water vole field signs. The locations of the ditches are shown in Figure 1.
