Lime Plant

Port Talbot Delivery Plan – Lime Plant

Tipping Location Risk Assessment

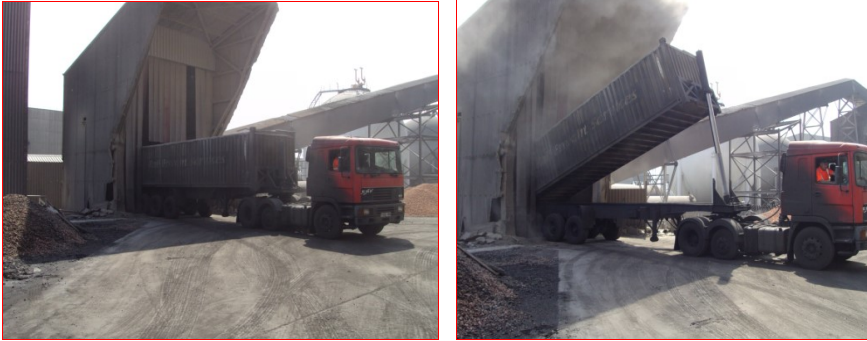
What is the method of unloading? E.g., *Forklift truck, Overhead Gantry Crane* **Truck tipping.**

Where should the driver be positioned during unloading? **Driver to report to the Lime Plant bunker man on arrival and then is to remain in his cab with his seatbelt on throughout the tipping operation while the tipper body is raised.**

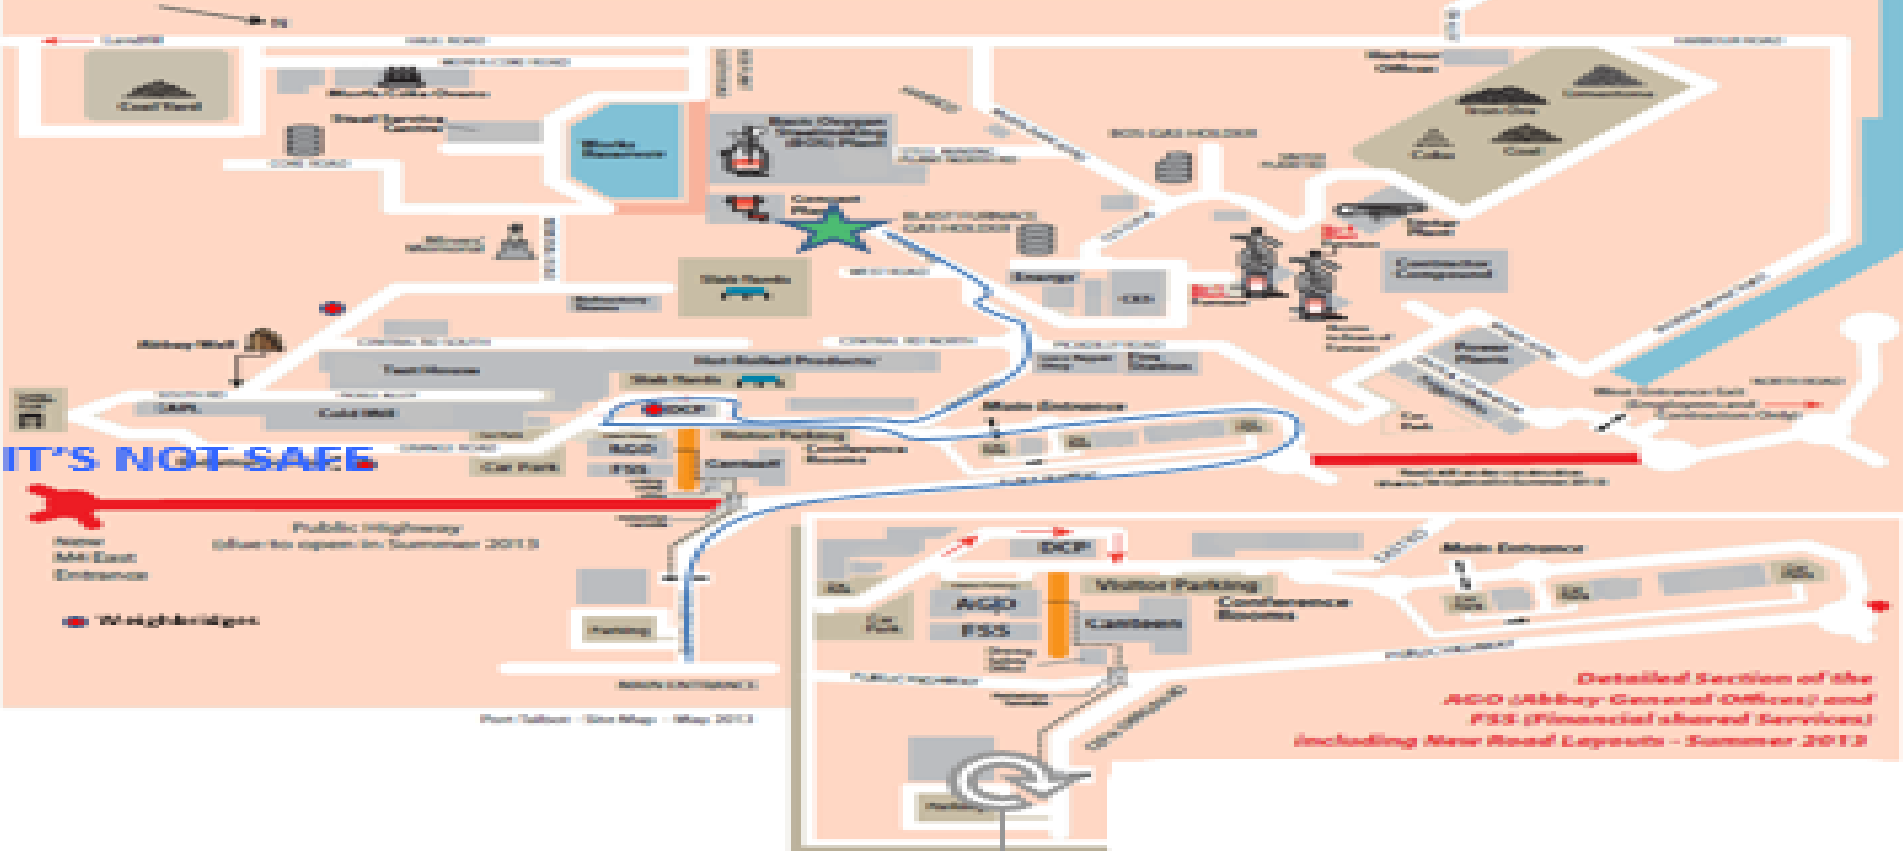
Map of Route:

- Roads
- HGV only road
- CLOSED ROAD
- New Dual Carriage Way
- Pedestrian Access
