Port Talbot - TCE

**Client Ref:** EAF Meltshop Project  
**Report Ref:** GSIP-2024-14959-18673\_SS\_2\_2  
**Grid Ref:** 278616, 187356

Project Name	Client	Report Reference
Tata Steelworks, Port Talbot	RSK Geosciences	S2RA-1004

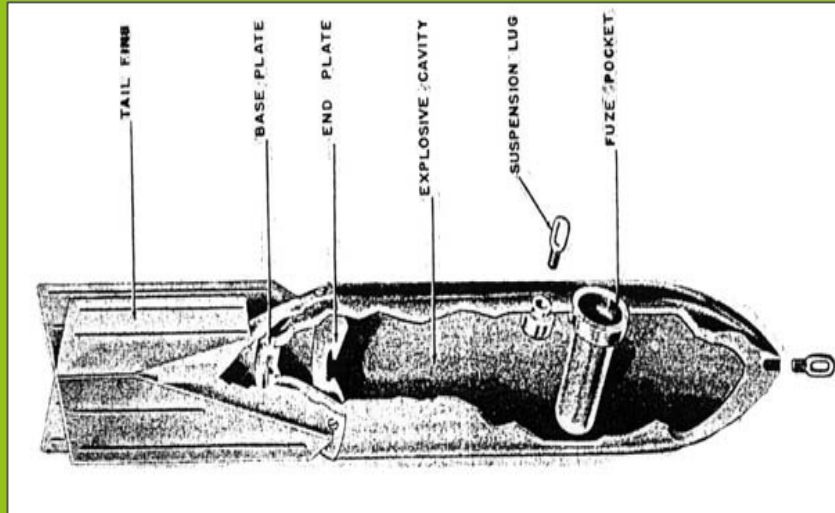
Bomb Weight	54kg
Weight of Explosive Fill	25kg amatol/TNT/trialen
Bomb Dimensions	1090mm x 280mm
Type of Fuze	Impact or electrical time delay
Notes	Most dropped bomb by weight over Britain. Useful against light targets.

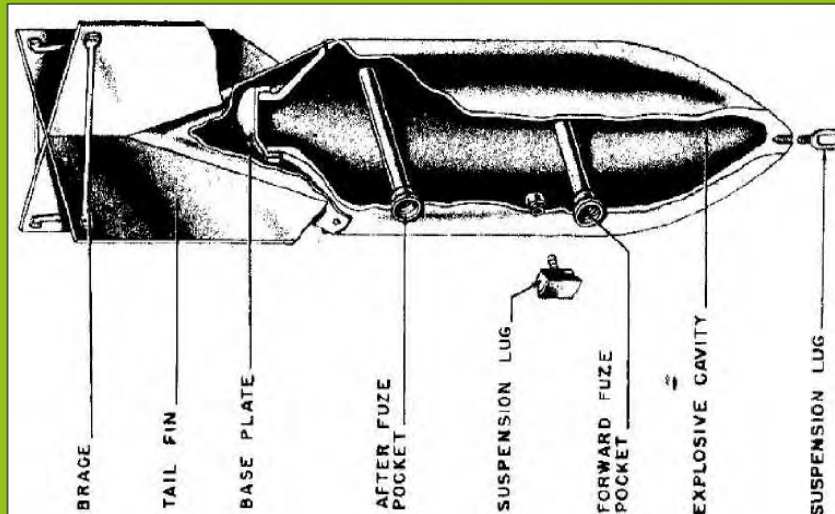
**250kg HE Bomb**

Bomb Weight	256kg
Weight of Explosive Fill	130kg amatol/TNT/trialen
Bomb Dimensions	1640mm x 512mm
Type of Fuze	Impact or electrical time delay
Notes	Increased penetrative ability proved useful against sub-terranean targets.

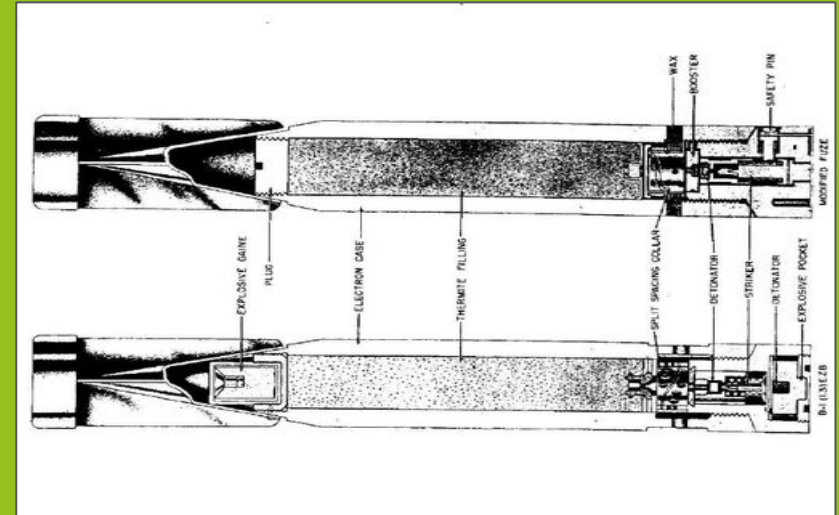
**2kg Incendiary Bomb**

Bomb Weight	2.2kg
Weight of Explosive Fill	100g HE bursting charge
Bomb Dimensions	311mm x 50mm
Type of Fuze	Electrical impact fuze
Notes	Dropped in container in batches of up to 372. Also had 1kg variant.

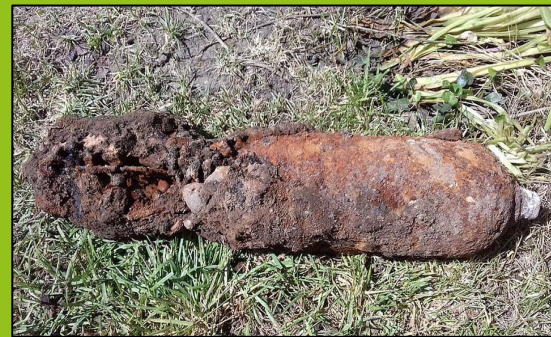
An unexploded 4.2" mortar found in a garden. Although corroded and dirty, the tail fins, teardrop body shape and No.152 fuze can be identified. Found less commonly than 2" mortars, 4.2" mortars possess a much higher Net Explosive Quantity.
